Planning and Protecting Historical Buildings in Kaleiçi Region of Edirne/Turkey

46th Congress of the European Regional Science Association: "Enlargement, Southern Europe and the Mediterranean", August 30th - September 3rd, 2006, Volos, Greece

PLANNING AND PROTECTING HISTORICAL BUILDINGS IN KALEIÇI REGION OF EDİRNE/TURKEY

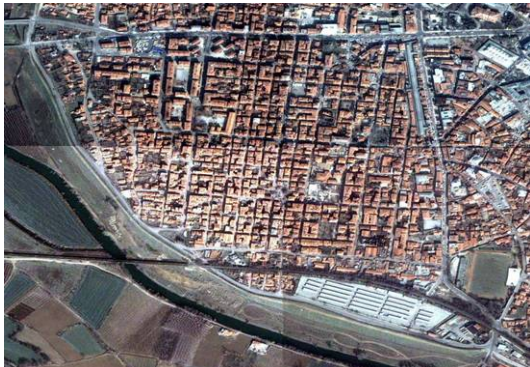
Figure 3. Location of the Kaleiçi in Edirne

Kaleiçi, which constitutes the first settlement core of Edirne city, covers approximately 26 ha-areas with the streets crossing each other vertically in a field in the form of a square surrounded by old ramparts, which have almost been destroyed today (Figure 3).

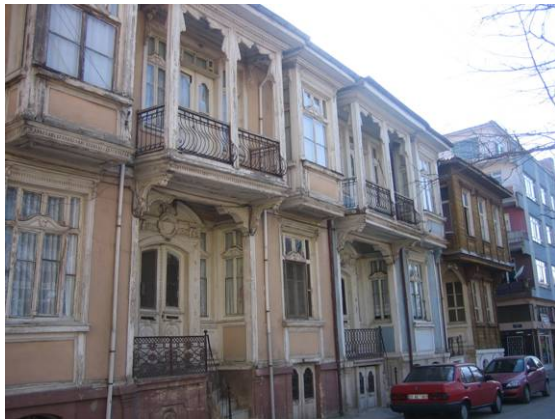
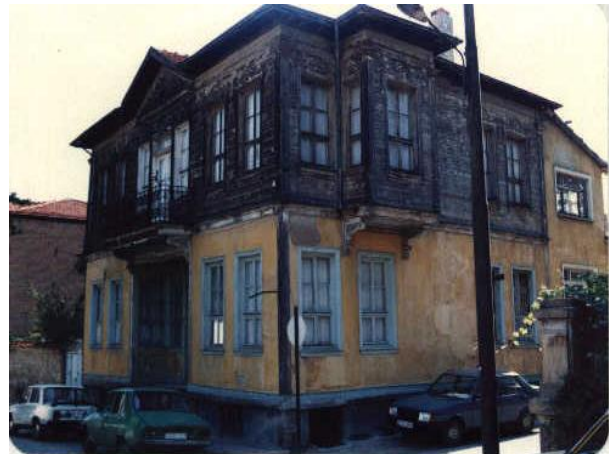
All of the houses were in a row and were built in the way that they faced the street. Houses in a row, unusual in the Ottoman city pattern, appeared as the architecture of the minority and reflected the socioeconomic characteristics of the era. (Batur ve diğ., 1979, s.185-203), (Figure 5, 6). 4 pairs of houses, designed as twin houses, took place in the area of settlement (Akansel, 1990, s.34).

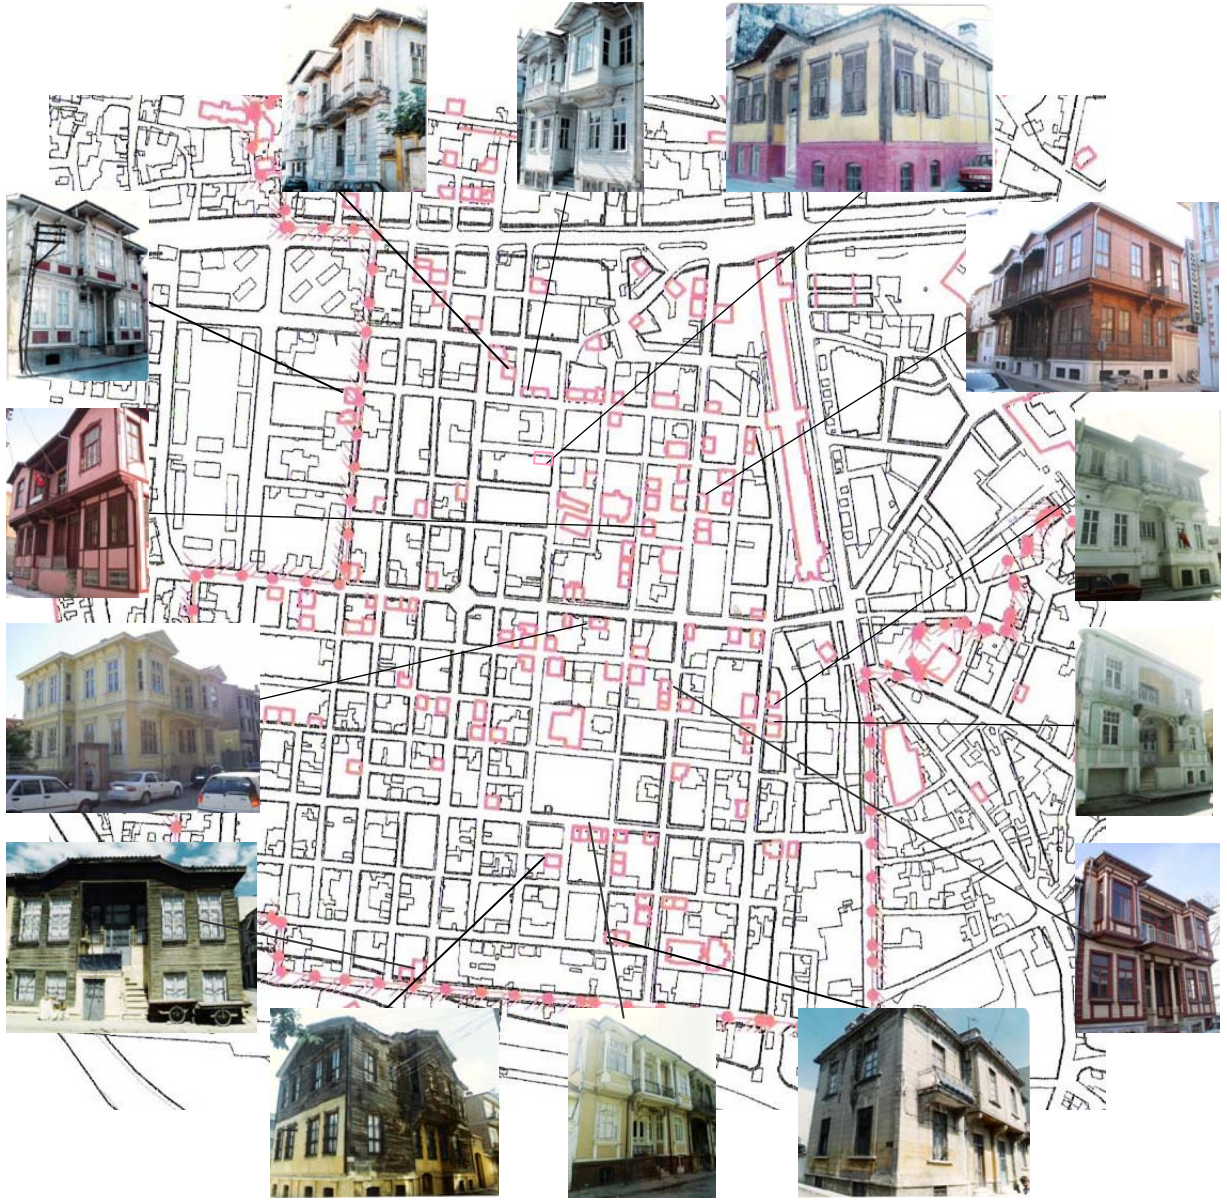
Figure 7. Views of Traditional Kaleiçi Houses in Edirne

Historical houses in Kaleiçi the entrances of which open directly to the street have generally two floors and a basement but no main floor that traditional Turkish houses have (Figure 8, 9)

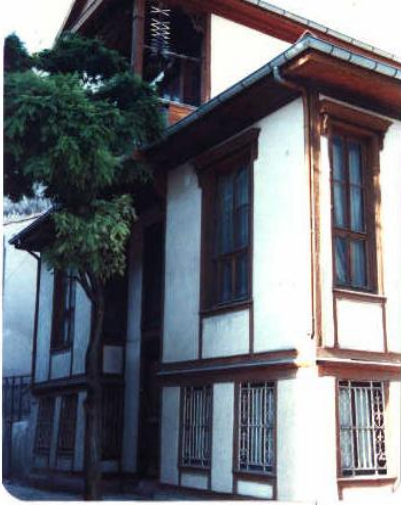
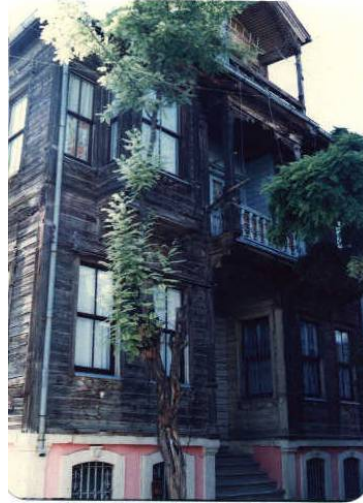
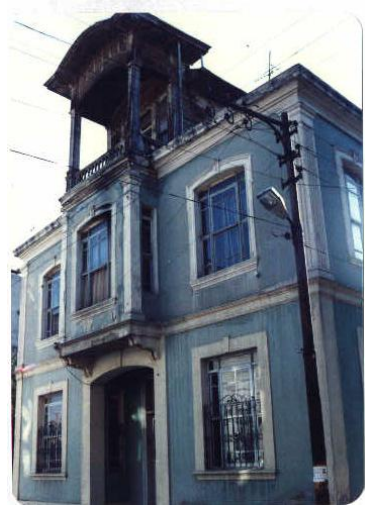
A roof terrace was also available both in the one-floor and two-floor houses although it was not used very frequently. There are also times when these were located in the attic storey in one-floor houses (Figure 13, 14, 15).

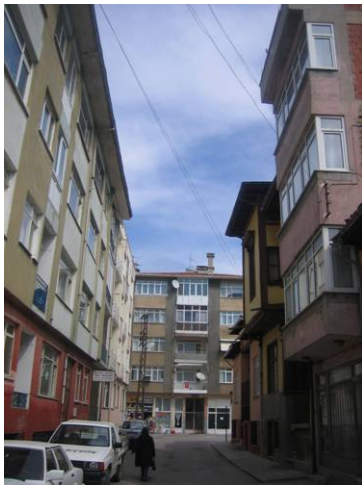
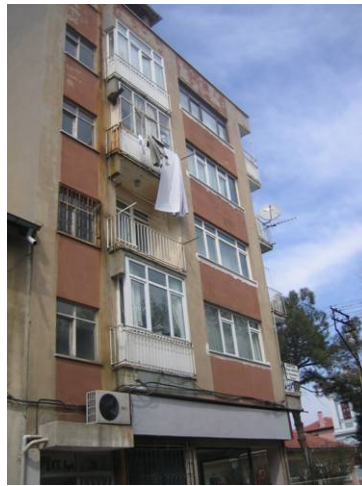
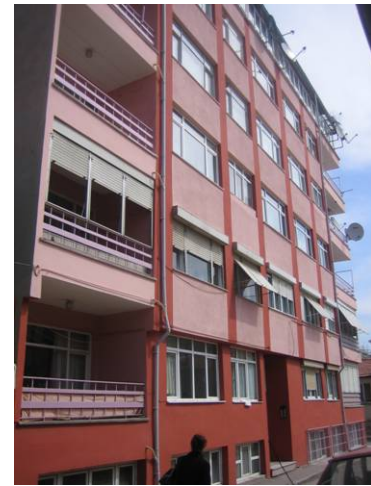
After the fires and earthquakes, 5 or 6-floor buildings destroying the traditional patterns and appearance have been built as a result of the regulations allowing construction and illegal applications (Figure 18, 19, 20).

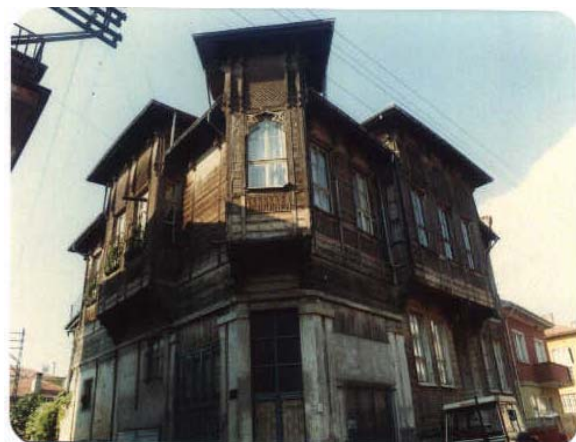
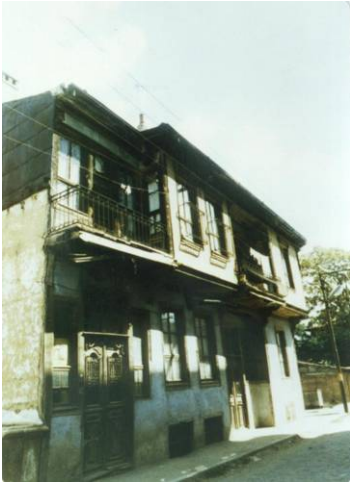
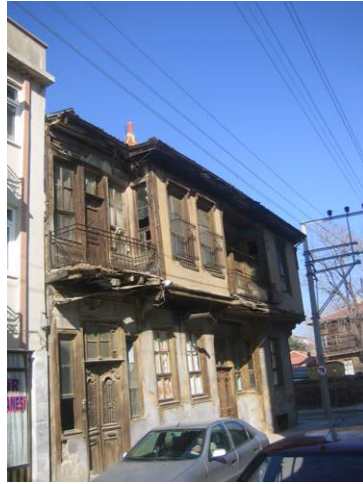
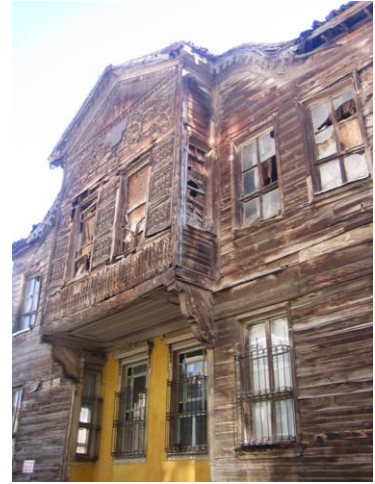
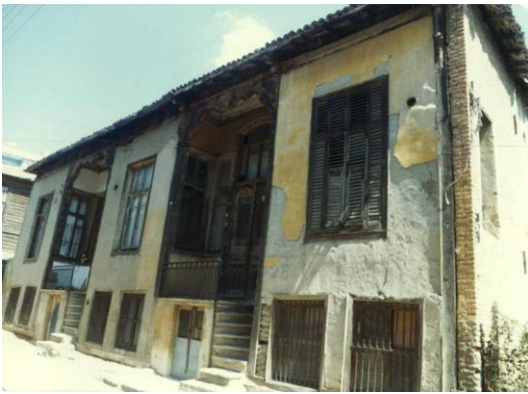
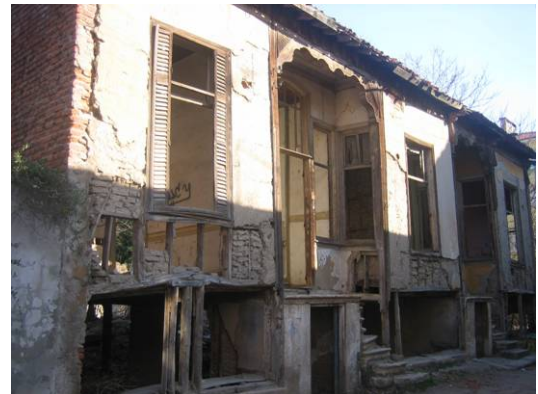
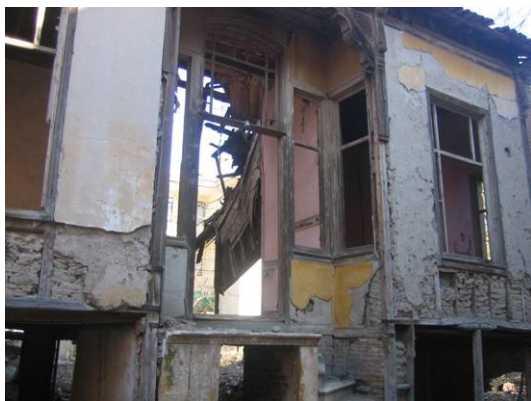
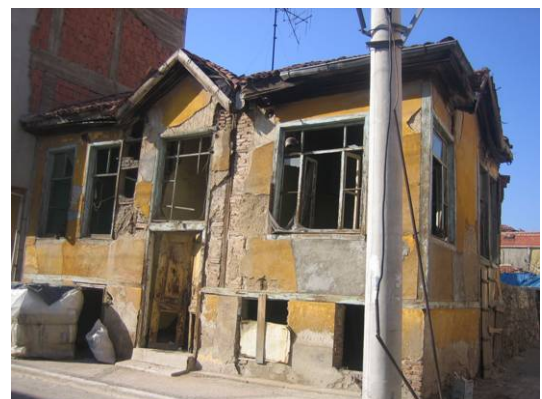
The changes mentioned have mainly affected the historical pattern. These houses, considered to be the sample of civilian architecture, either destroyed and more dense buildings were built instead: or left in a bad condition within the framework of the power of protection rules because modern life conditions could not be provided. Because of the reasons such as the insufficiency in the economic and social structure of the users of these ruined houses, we have some problems waiting to be solved such as that these houses left their liveliness and some of the houses near to the trade region were put into the function of trade; and need

for the car park and vehicular traffic (Figure 21, 22, 23, 24, 25, 26, 27, 28)
